NUKE INFO TOKYO

May/June 2013
No. 154

Citizens' Nuclear Information Center

Fukushima Daiichi Nuclear Power Station: Still too many unknowns about the accident and the current condition of the plant

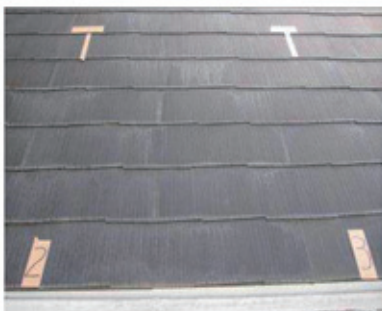
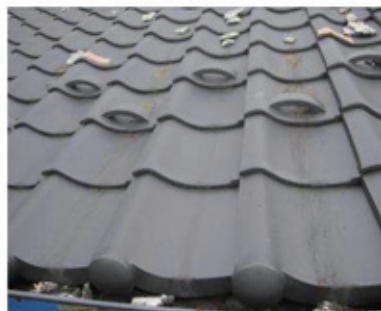
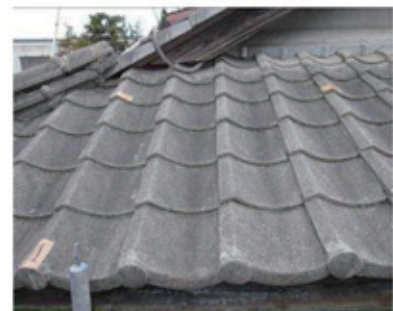
Figure 2. Roofing Materials
Left to right: slate roof, clay tiles, cement tiles

Looking, for example at the radioactive material decontamination rate for wiping methods, a 57% effectiveness was achieved for house walls and so on. While it was as high as 77% for clay roof tiles, only low effectiveness was achieved for cement tiles (0%) and slate roofs (24%). In cases where the clay tiles contained cracks, the decontamination effectiveness was 0%. As a result of house decontamination, the air dose rate in the vicinity of the house at a height above the ground surface of 1 m was reduced by an average of 18% to 74%. Out of ten model decontamination zones, only three zones were able to reach the 50% reduction target. It would seem that the expected effectiveness could not be achieved in actuality.

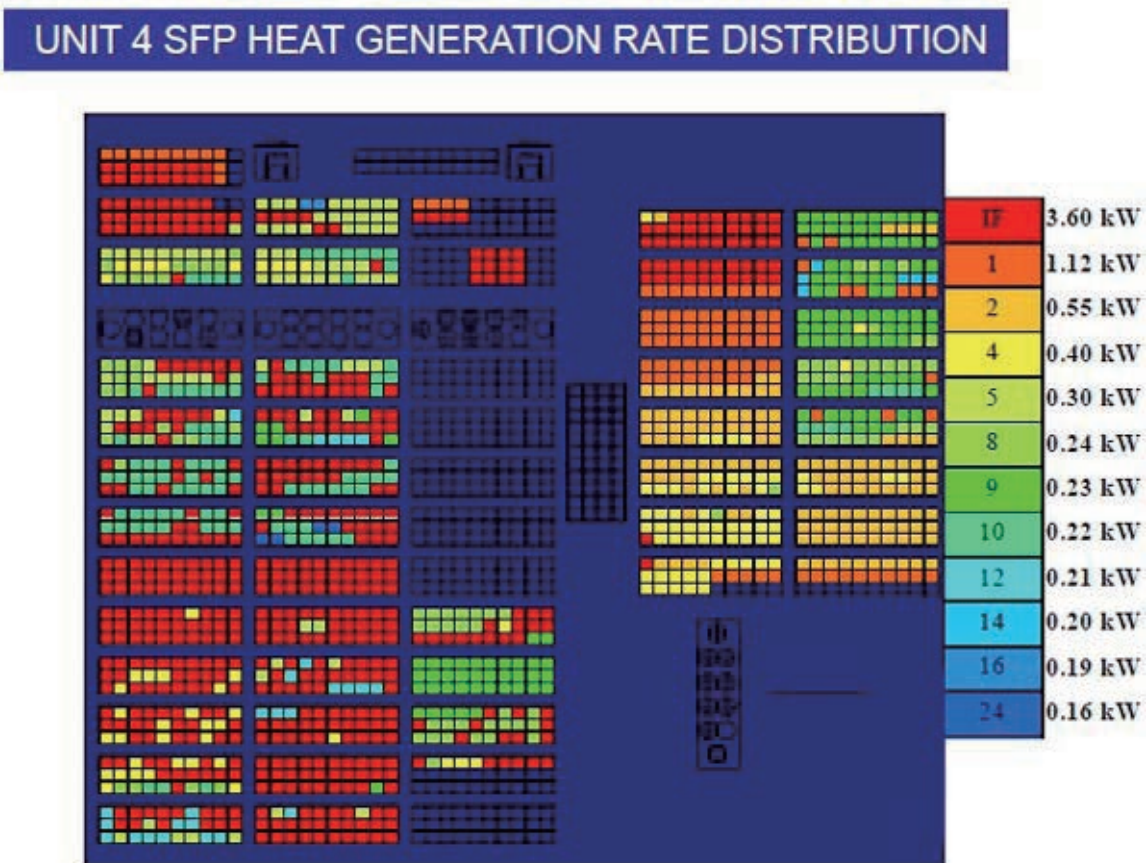
Figure 2; Unit 4 Fuel Storage Configuration
 Reproduced from "DOE Response to Fukushima Dai-ichi Accident," by John E. Kelly, May 26, 2011, available at <http://pbadupws.nrc.gov/docs/ML1114/ML11147A075.pdf> (page 188/210).
 TEPCO provided this configuration to the US Department of Energy (DOE), but to date has not published it in Japan.

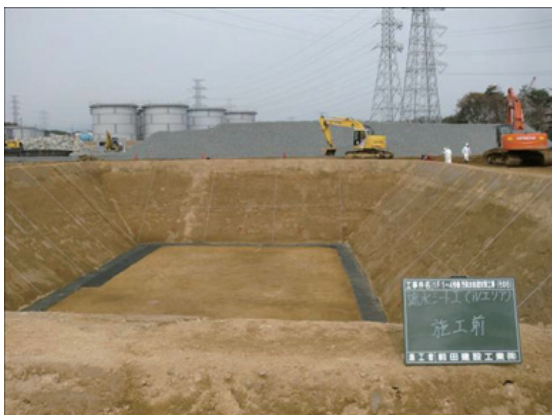
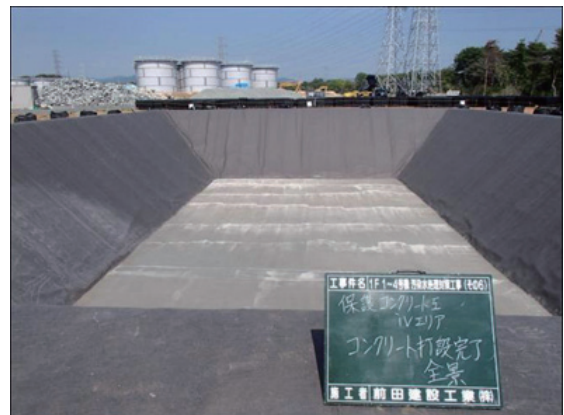
Figure 1. Photos of an underground tank for contaminated water (Photos by TEPCO)

Leaking of the contaminated water was first discovered in the No.2 storage pool. This was made public late at night on April 5. The leaking pool measures 60m in length, 53m in width, and 6m in depth, and was filled with 13,000 tons of contaminated water. Judging from the fact that the water level began declining and radioactivity was detected from the water samples collected from the detection holes, TEPCO appears to have suspected that the water leaks began sometime around March 20. The radioactivity levels of the sampled water continued to surge, while the water level in the pool declined further, forcing TEPCO to disclose the water leaks.

TEPCO explained that since the leak monitoring pipe passes through the lining material covering the top of the pool, the company had previously presumed that the lining had moved slightly due to the weight of the water, creating a space around the pipe, allowing water to seep out. If this analysis were correct, the water leak would continue only for a limited time, until the water level dropped. Moreover, water leaks would not occur there unless the pool was full.

The reality is that leaks were discovered when the No.1 storage pool, containing highly radioactive water from other storage pools, was half full. TEPCO's explanation contradicted this fact and was therefore proved false. As a result, the most likely cause of the water leaks would be a tear in the liner, or a gap created where liner sections are joined.

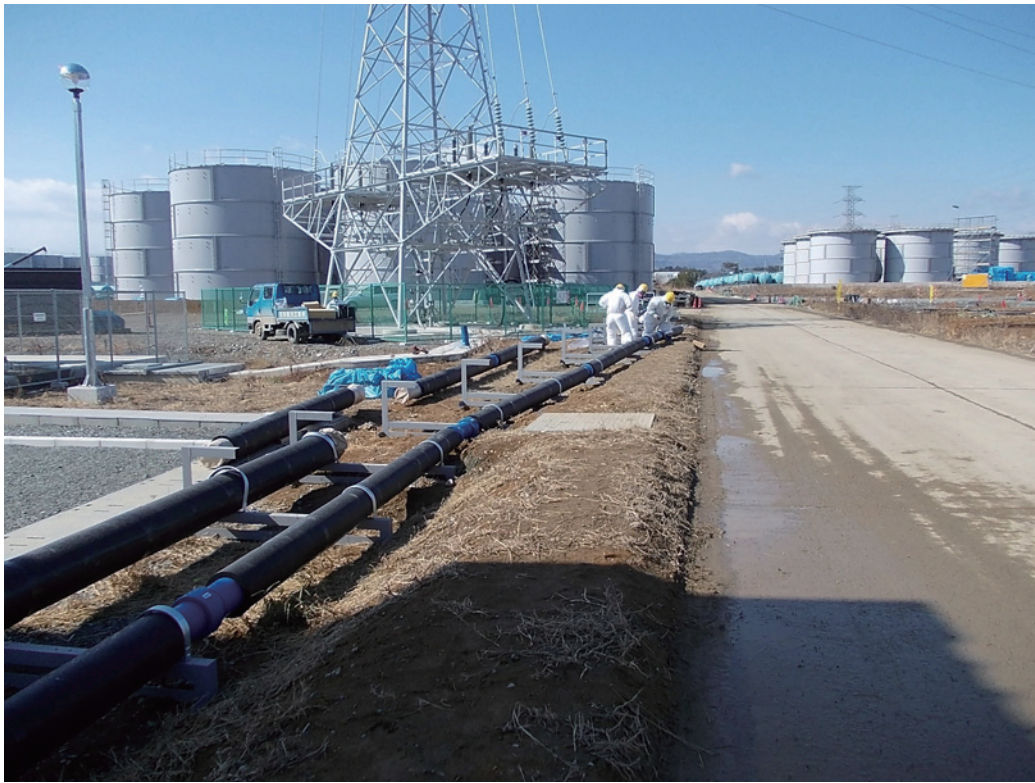
Figure 2. Some of the large number of storage tanks at Fukushima Daiichi Nuclear Power Plant (Photo by TEPCO)

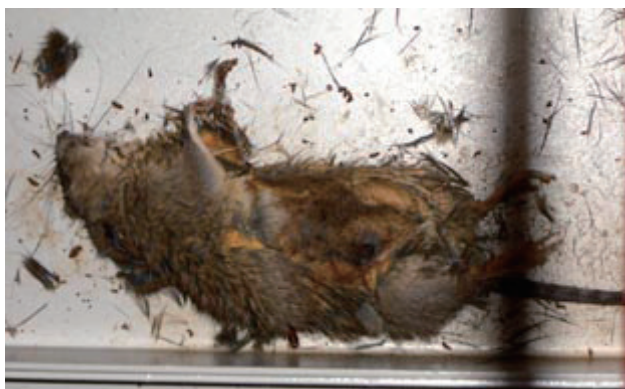
Photo of the corpse of the rat that stopped the spent fuel pool cooling system (TEPCO)

On March 18 at TEPCO's Fukushima Daiichi Nuclear Power Plant, a rat somehow gained entry to an outdoor electrical junction box, resulting in a loss of power when it caused a short by touching a terminal. The spent fuel pools of Units 1, 2, and 3 (now undergoing decommissioning due to the March 2011 accident) and the common fuel pool could not be cooled from between 19 and a half to 29 hours. On April 5, while installing a steel mesh fence as a countermeasure, a wire from the steel mesh came into contact with a terminal in the junction box, causing another short and making the cooling for Unit 3 spent fuel pool inoperable for three hours. Furthermore, on April 22, two dead rats were found inside an outdoor transformer, causing the Unit 2 spent fuel cooling to be suspended for 4 hours while the rats were removed and the transformer inspected.
