NUKE INFO TOKYO

Hamaoka Nuclear Power Reactor 1

-Pipe Rupture and Water Leak from Pressure Vessel

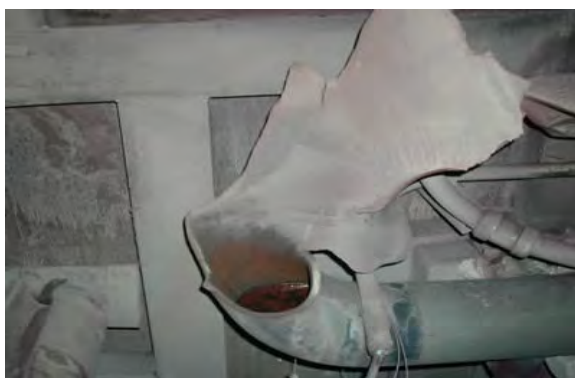
The extent of the damage caused by the rupture can be seen from one glance at the picture released by Chubu Electric (see photo 1). Not only was the pipe damaged, but the surrounding area was badly affected – the metal support structures were torn off, and the grating bent over. The walls in the vicinity of the area

had some dents which might have been caused by violent motion of the pipe. The blown-off portion of the pipe was found in four large fragments and another fragment was found on a later day. It is possible that these pieces shot off like missiles and damaged adjacent equipment. No damage from chemical corrosion or stress has been found on the surface of the damaged pipe.

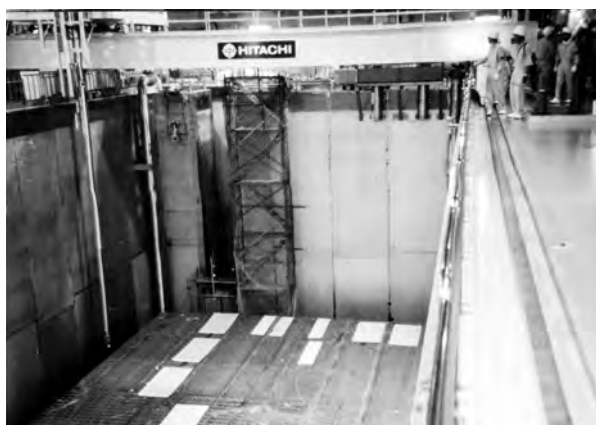
The photo shows a wall of the pool without any water. This picture was taken when a spot inspection was conducted in haste before the cooling water was injected into the pool. The photography was done by court order in the course of the litigation concerning the admission of the pool and other reprocessing plant facilities. The photography shows welded parts that are not even due to defective grinder finish, other parts where grinder finish was used to hide flaws on the wall or used mistakenly on non-welded parts, etc. It is quite obvious that the construction of the pool was carried out in a sloppy manner.
